BULLETIN TITLE: FRONT UNDERCARRIAGE INSPECTION		
	CLASSIFICATION: MANDATORY SERVICE BULLETIN SAFETY DIRECTIVE/ALERT		
	BULLETIN NUMBER: ALL-SB-0-0-0-ALL-0003-2025		
	Date of issue: 14.07.2025	Revision no.: 0 (1st Issue)	Page: 1
Letecká 255 686 04 Kunovice Czech Republic	Tel.: +420 773 984 338 info@brmaero.com www.brmaero.com	Date of effect: 14.07.2025	Date of rev.: - Pages: 7

6.1 ANNEX 1 Photographic documentation

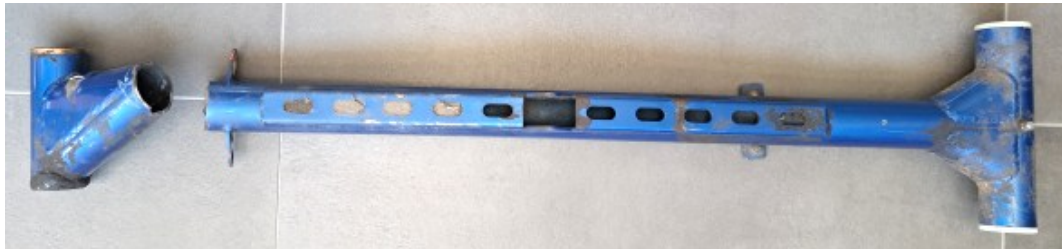
- 1.2 Reason**
 One of the aircraft in service had the lower end of the front landing gear leg broken off; see 6.1 ANNEX 1 Photographic documentation. The cause was a gradual fatigue fracture.
 The occurrence could have been prevented by thorough pre-flight and periodic inspections (see 2.2), during which starting cracks should be detected.

Figure 1 Front undercarriage leg with broken lower end.

- 1.3 Required action**
 Visual inspection of the front undercarriage leg and fork for possible cracks, especially around welds and for deformation.
 Consistent performance of the prescribed inspections of the airplane (see 2.2).

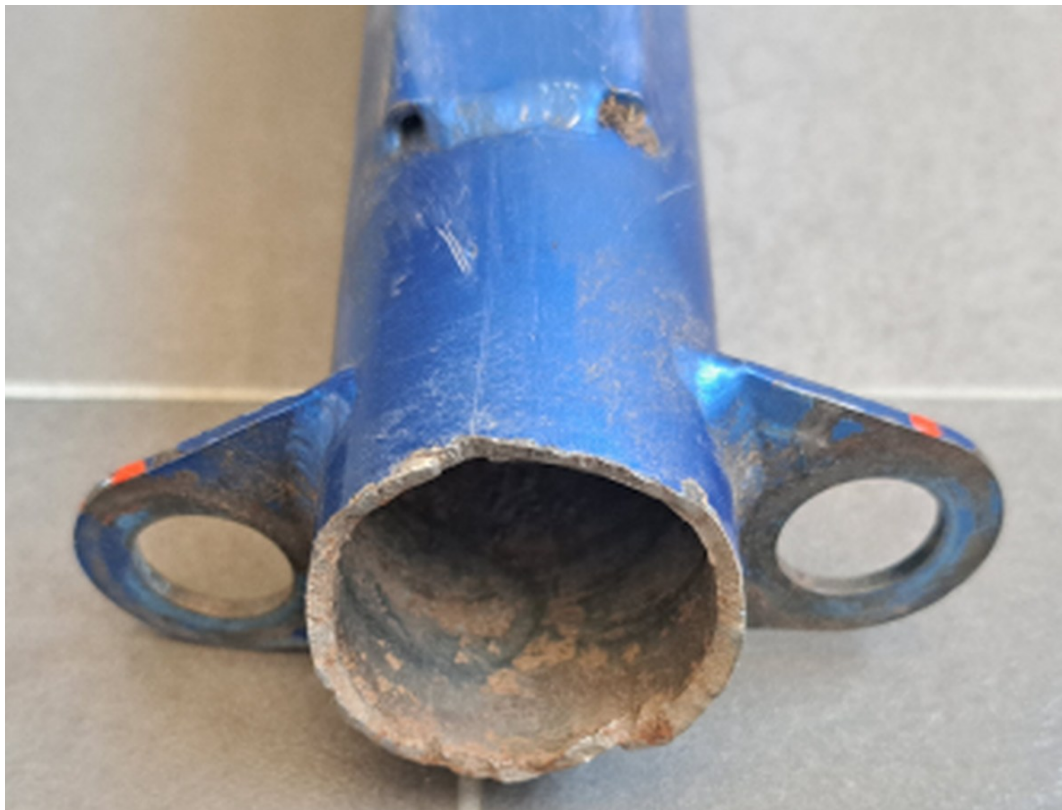
Figure 2 The fracture surface at the end of the leg.

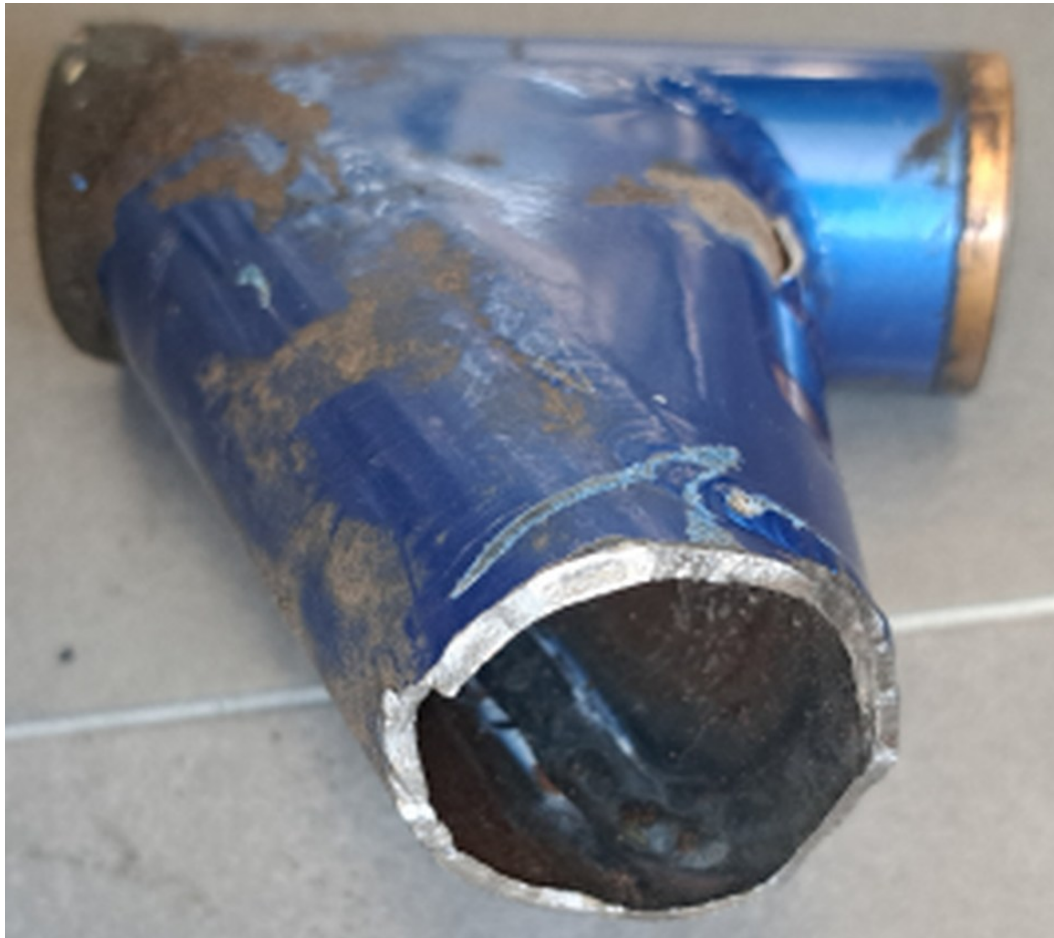
Figure 3 Fracture area on the lower broken part of the leg
